**The Monadnock Building**  
Chicago, Illinois

# Tech Notes

## HISTORIC INTERIOR SPACES

#### Preserving Historic Office Building Corridors

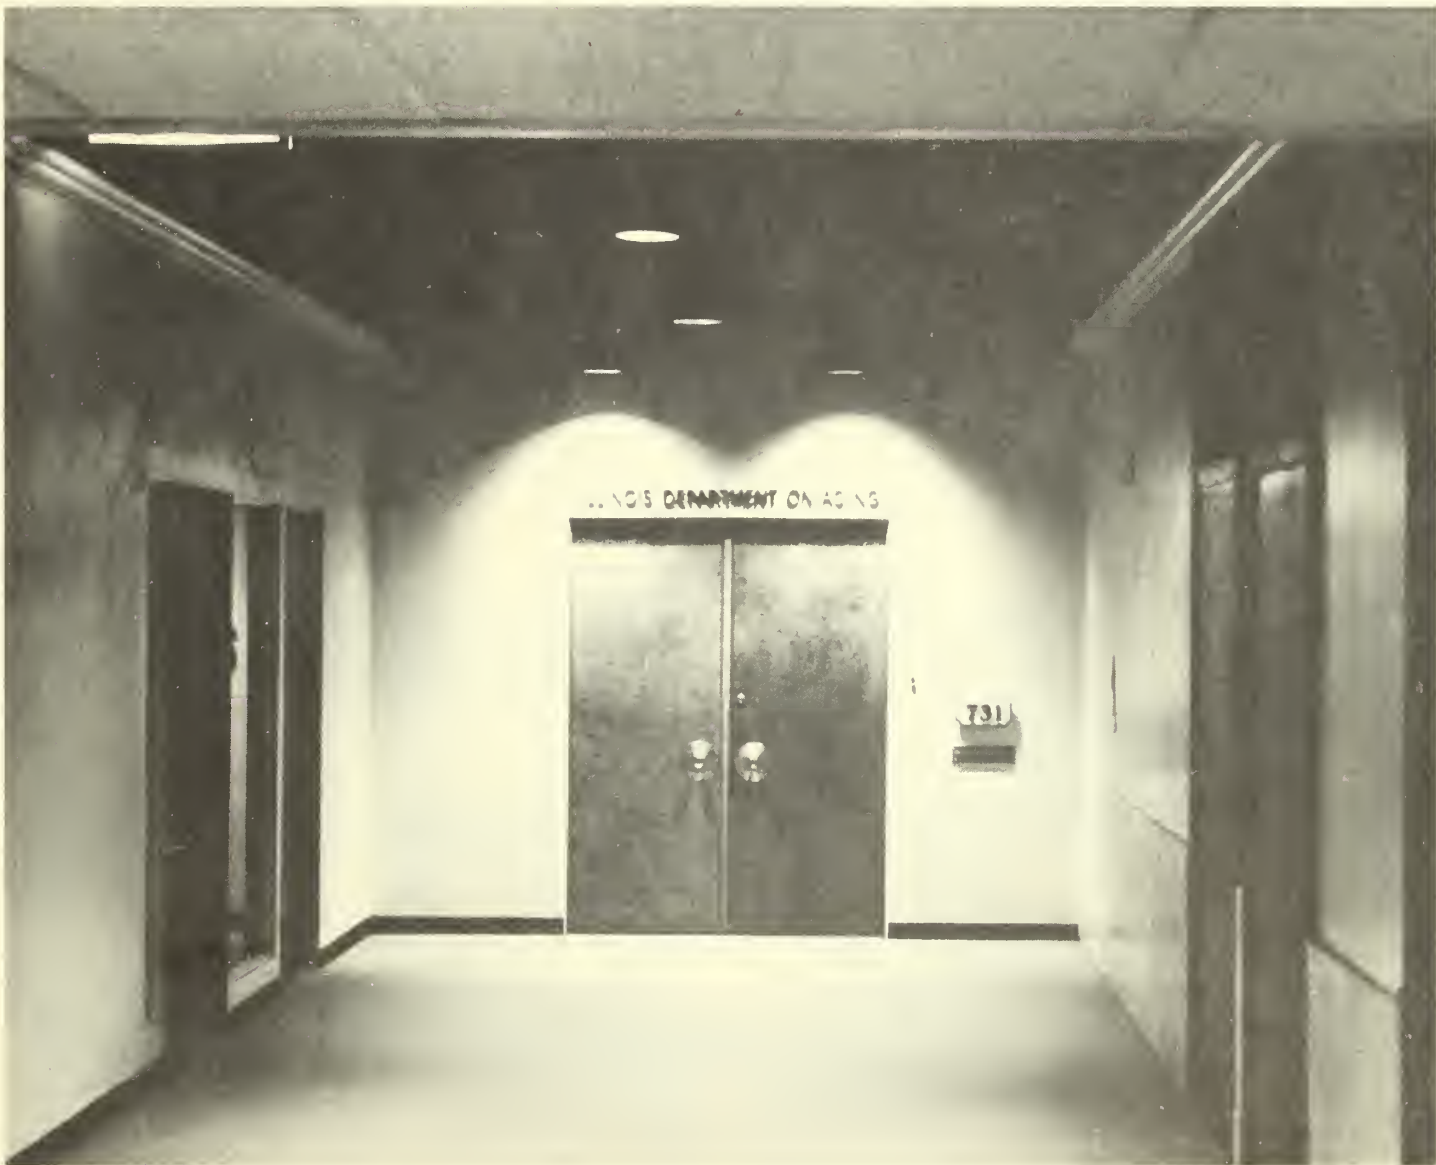
The Monadnock's historic interior corridors and office suites had suffered considerably because of past insensitive remodeling. Prior owners had dropped ceilings for mechanical equipment, removed large sections of the historic marble wainscotting, and painted over the ornamental cast-iron staircases and bronze door hardware. Almost all of the feather-chipped glass partitions, oak trim, and glass

office doors and transoms had been removed or covered over. On several floors the corridors had been entirely removed or shortened to accommodate open floor plan offices. (See figure 2).

Figure 2. Typical condition of public corridors prior to rehabilitation. Glass and oak corridor partitions and much of the marble wainscot was either removed or covered. Ceilings were suspended and sections of the corridor plan were shortened or removed. Photo: William S. Donnell

A third, more historically sensitive option was chosen. This option involved retaining the existing historic corridors and re-establishing corridors to match the historic ones on floors where they had been removed. The plans also called for smaller individual offices with a basic office module of about 600 square feet, which was close to the size of the historic office suites. (The marketing plan targeted lawyers and other professional businesses requiring smaller office spaces).

Historic drawings were used as the basis for reconstructing the missing corridors according to Burnham and Root's original design. Rehabilitation plans also included the repair and rebuilding of missing sections of the ornamental iron staircases. A few existing corridors, though missing some historic features, were left intact with plans to replace the missing historic elements sometime in the future. This allowed the building to remain occupied during the rehabilitation.

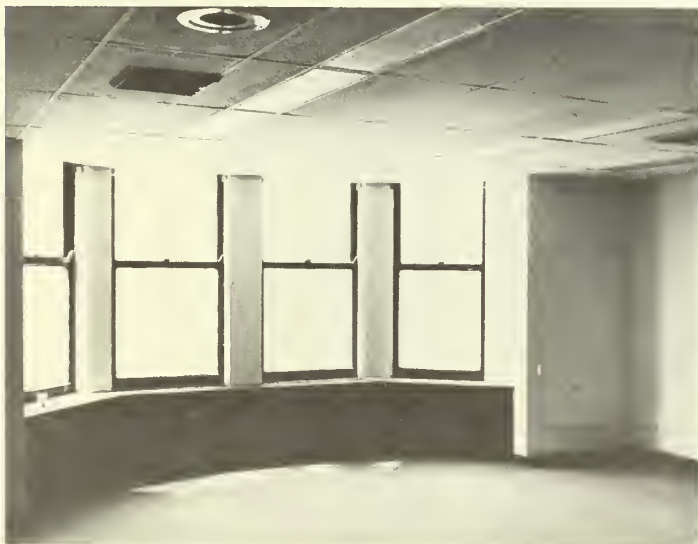
**Figure 5.** Typical pre-rehabilitation condition in private offices. Approximately 60 percent of all office interiors had suspended ceilings, blocked-down windows and radiator enclosures. Note inappropriate way dropped ceiling abuts windows. Photo: William S. Donnell

The Monadnock was purchased in 1979 by the current owners for \$5 per square foot. The original one-pipe steam heating system was still in place at the time. Rather than replace the existing system with a more costly forced-air unit, the steam system was repaired for less than \$1 per square foot. This included new boilers and controls, asbestos abatement, and new Ammark valves at the radiators.

The German Ammark valves are thermostatically controlled and regulate both steam and return condensation in one pipe. Considerable space was saved by using the existing steam system, and avoiding massive forced air duct work or piping for a new steam system (see figures 5 and 6).

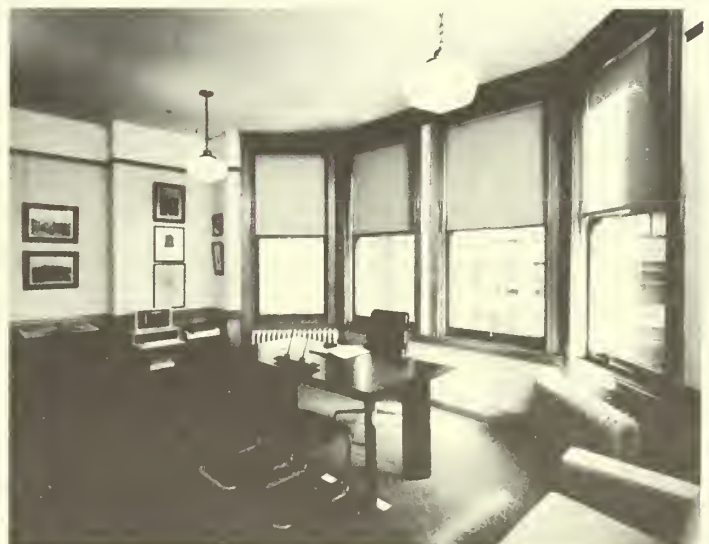
**Figure 6.** Typical 600 square foot office module after rehabilitation, with full ceiling height and one stand pipe radiator heat. Photo: Ron Gordon

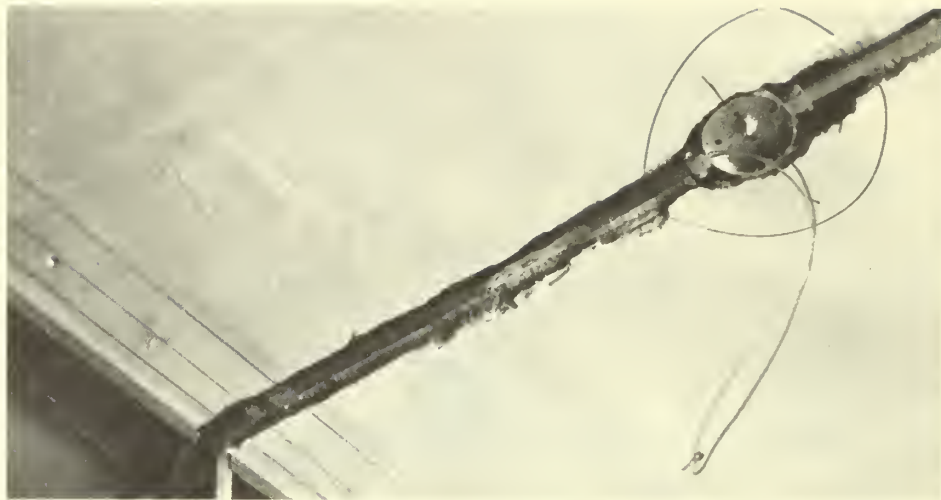
**Figure 7. Channeled corridor ceiling with oval electrical conduit installed. Replastered channel matches existing ceiling, concealing new electrical distribution system for the entire building. Photo: William S. Donnell**

Upgrading the electrical distribution system provided a challenge in corridors that retained the full historic ceiling height. Floor sections in the Monadnock are constructed of 12-inch to 13-inch hollow terra-cotta tiles topped with a cementitious mortar and finished below with ceiling plaster. Running new electrical conduit through the hollow floor sections was explored, but rejected because of misalignment of the terra-cotta sections. An alternative solution proved to be more feasible. A new primary electrical distribution system, together with a backup emergency system, was

installed in the building by carefully channeling the ceiling plaster and attaching 3/4-inch oval conduit to the hollow terra-cotta floor sections. The channels were then replastered to match the surrounding ceiling (See figure 7). Dropped ceilings in the anterooms also provided for electrical chases servicing secretarial and private office spaces.

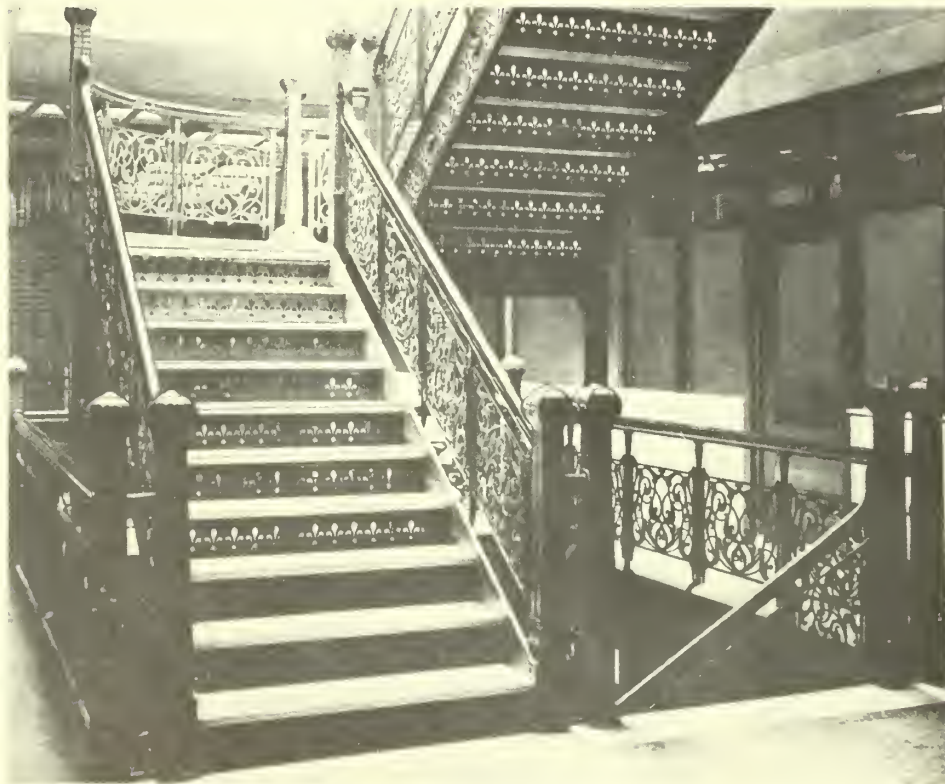
**Figure 8. Burnham and Root's aluminum and bronze plated cast-iron stair remains the most notable architectural feature in the north half of the building. Minor repair work and a few missing elements have been replaced with cast aluminum. Favorable building codes allowed the open design.**

The ornamental open staircases are significant architectural features and a major focal point of the corridors in both the north and south halves of the building (See figure 8). Beyond their architectural significance, the stairs in the north half of the building from street level to the first floor are cast aluminum and represent the first use of this metal in a building. Upper flights are made of bronze-plated cast iron. These open stairs were allowed to remain intact under a provision of the Chicago Building Code that waives certain code requirements for buildings where

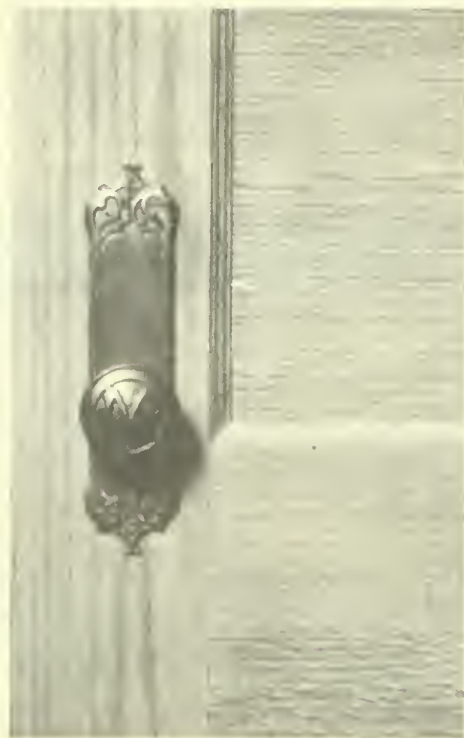
**Figure 9. Original cast-iron door hardware retained in corridors. Photo: Ron Gordon**

Originally the Monadnock featured Bower-Barff cast-iron door hardware, which is cast iron that has been

reheated in the manufacturing process to form a dark corrosion-resistant finish simulating cast oxidized bronze. During the course of the rehabilitation, missing and damaged hardware was replaced with actual cast oxidized bronze (See figure 9). As a result, these important historic features remain significant elements within the Monadnock's corridors.

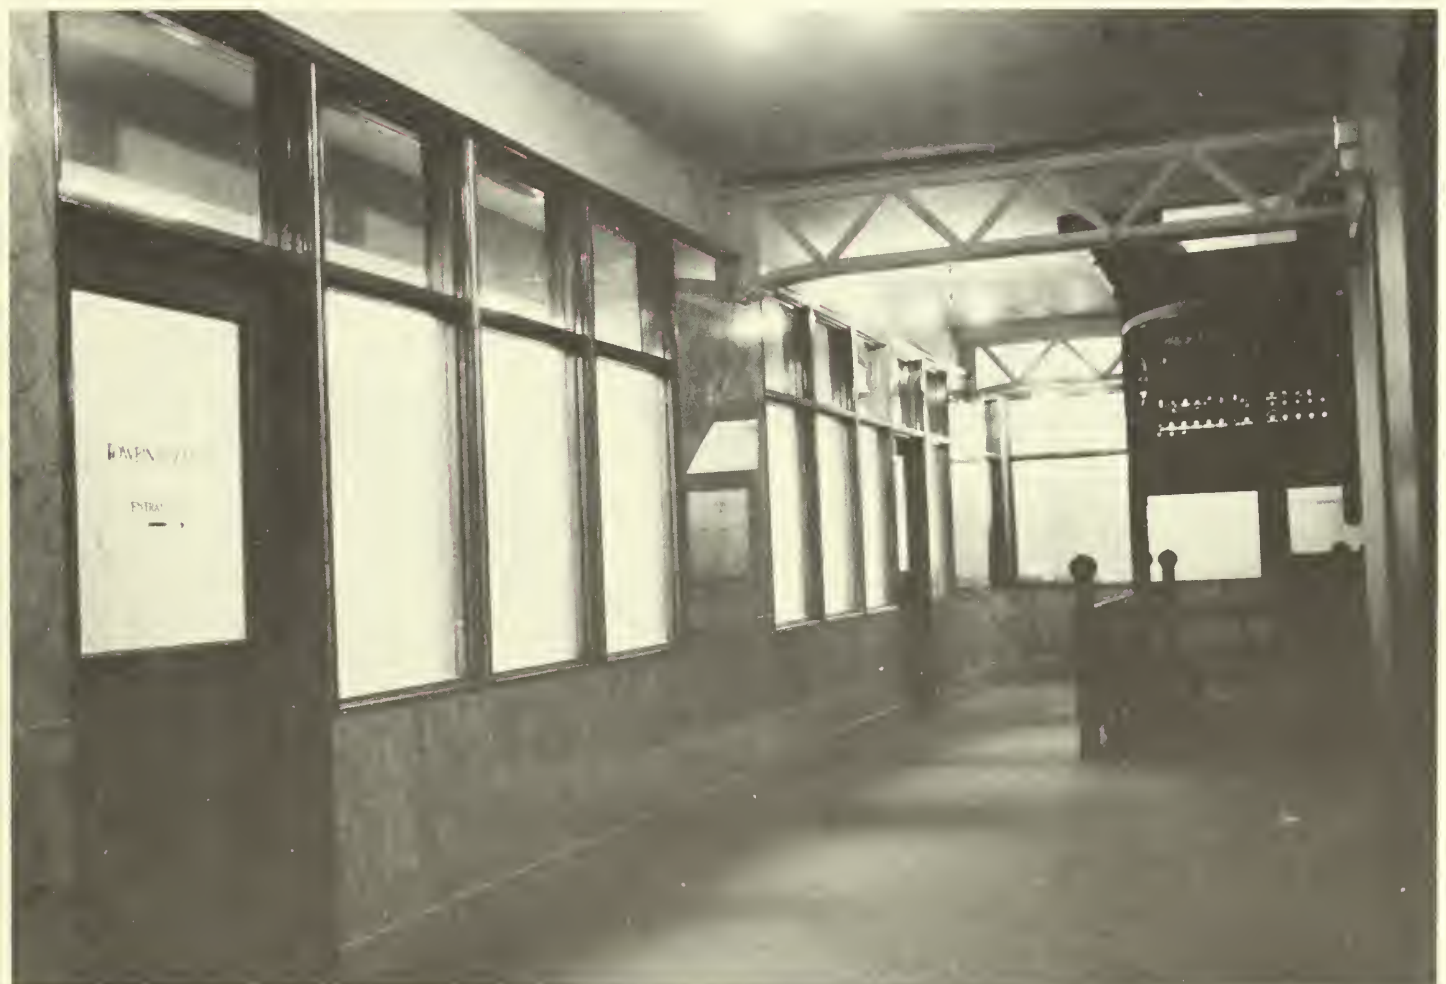
Figure 10. Rehabilitated corridor showing marble wainscot, oak and feather-chipped glass corridor partitions, full ceiling height and open ornamental stairs. Photo: Ron Gordon

The rehabilitation philosophy of retaining and repairing historic corridor fabric where possible and replacing missing elements to match the historic plans proved to have an economic advantage over comparable new construction. While typical office rehabilitations in Chicago require an average investment of \$100 per square foot, the rehabilitation of the Monadnock cost under \$50 per square foot (See figure 10).
